Paper for AOCP on 16 September 2021

Flood Cell 9 Hazlewood Marshes

FC 9 Annex

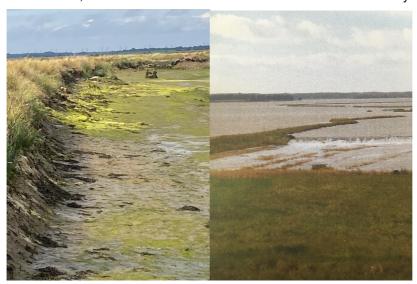
Unfortunately, the old river wall is now subject to erosion that was not anticipated in 2013. Northerly winds blowing across the flooded area are able to attack what was originally the rear face of this wall, (which like all the inland side of the estuary's river walls is not concrete faced): this erosion is the most likely cause by which the spur will be lost in the next few years. Once lost, the erosion on the inner wall will be increased and its life shortened significantly, leading to increased flooding. Equally if further breaches occur in the river wall as it collapses, the tidal inflow to the area and out will increase with likely consequences for the estuary flow as a whole.

Photos: Wall being undermined from the rear north side and, right, inner wall at exceptional tide flooding with spur beyond which is being undermined from the rear as in detailed photo.

Possible solution- this is just one idea, but first a clear assessment of what is developing is needed but the idea is mentioned here to give an idea of the possible modest scale of works: Unusually for this estuary, a solution may be quite straight forward. Extending the stake and plastic breakwater that protects the new inner Wall along the rear face of the old wall spur will be sufficient to protect against the waves generated within the flood cell, which are much smaller than those in the main estuary.
