Suffolk Estuary Flood Defence and Right of Way Trial on the Deben Estuary, (Flood Cell 12), north of Martlesham Creek

Update April 2016 – including interim recommendations

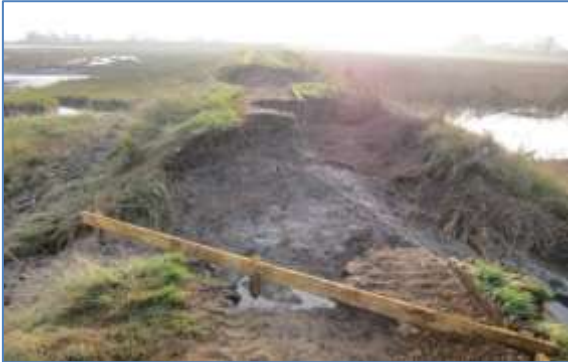
An example of an estuary defence footpath damaged in December 2013 surge

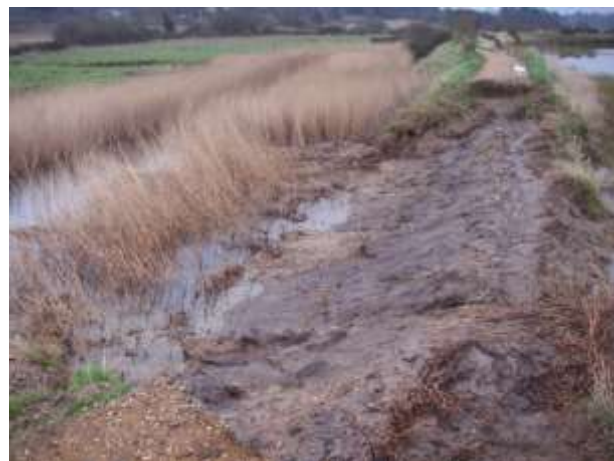
Following significant damage to the wall (see picture below), as a result of the tidal surge of December 2013, a sustainable approach to the defence restoration was required.

In order to ensure minimum damage in any future surge event the design implemented allows the flood cell to drown out using grass reinforced spillways – areas lower than the main wall height. The lower level of each of the two spillways should result in overtopping at least once every winter on extreme spring or surge tides. When water flows over the spillways it results in full submergence of the grazing marshes behind the wall. This prevents overtopping of the higher, steeper sections of river wall, which are in a poor condition and liable to breaching. This design was regarded by the landowner as the most cost effective option – the more expensive alternative would have been to strengthen and broaden the whole length of the wall.

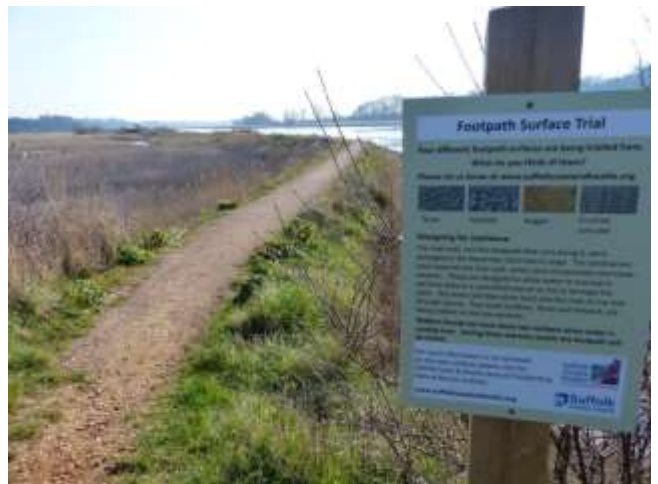
Crushed concrete – initially it was intended that type 1 crushed concrete would provide a good walking surface but the poor quality of the material provided resulted in the need for a layer of granite fines to be laid about a month later. Note this was also the case for infilling the Tenax. *Photo right.*

Vegetation is re-growing at the edges.

This section of the path is level and firm and is a good walking surface.

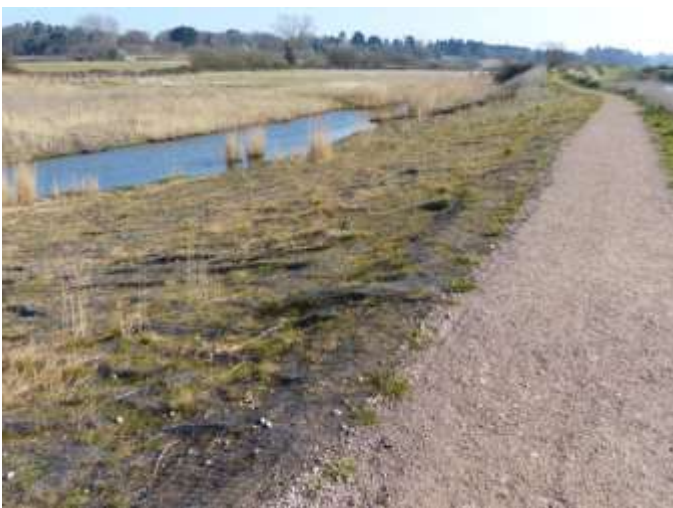
Tenax infilled with crushed concrete and granite fines: The grids are mostly covered and material does not appear to have washed out/eroded out of the cells. *Picture left.*

Vegetation is growing at the edges and on the backslope (except where the mesh was not pinned down flat).

It is level and firm to walk on and is very similar to the crushed concrete surface without the cells.

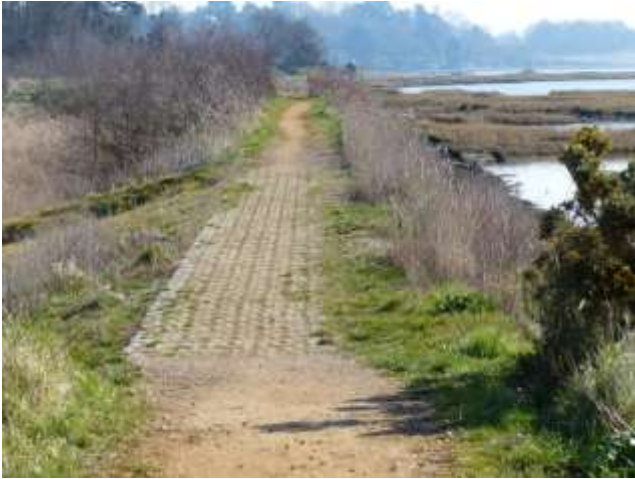
Ankalok blocks, March 2016

Ankalok blocks infilled with crushed concrete: The blocks remain in place and are firm and there is some vegetation growth between them. .

The Ankalok blocks are less satisfactory and at this stage Suffolk Rights of Way will not be recommending their use as a walking surface over and above the other surfaces trialled on this footpath. The use of concrete products specifically designed for walking surfaces may ultimately prove more acceptable.

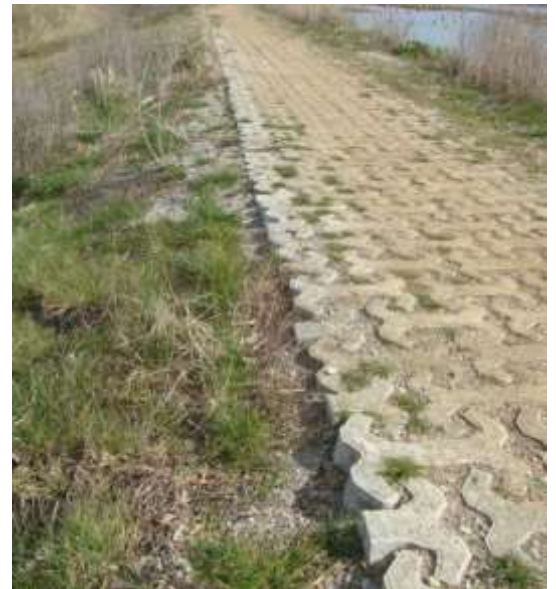
At the edges where the soil is flush with the surface of the blocks, the vegetation has regrown but there are short sections where the blocks stand proud (*photo right*)

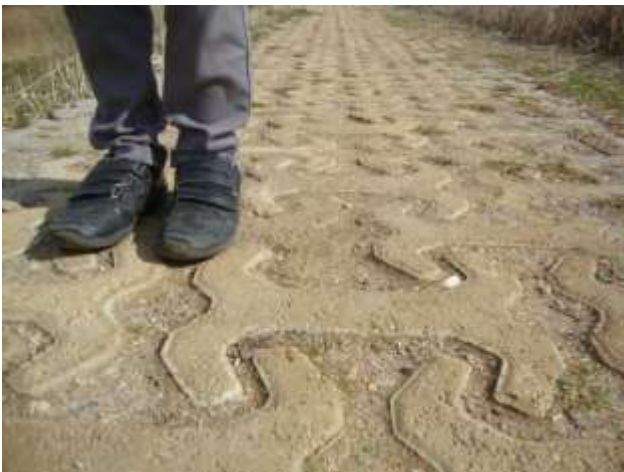
The infill material is at a lower level than the surface of the blocks - material may have settled or washed/eroded since installation. The blocks are not all at the same level and although the differences in height are small at present (1cm), it is a concern that with further settlement or loss of infill, they will become trip hazards (*photo below*).

There is an inclination to walk this section watching your step.

It may be that there are other concrete products designed with walking in mind that might perhaps have avoided these issues – for example blocks fixed onto matting or those with different dimensions between block and infill spaces.

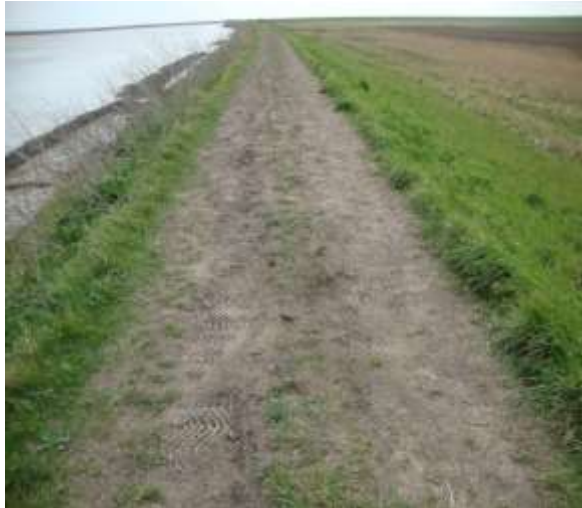
The trial area

Subsequently this path has endured much use and several wet winters. The turfmesh has become exposed and there is little grass on the path. There are numerous locations where there are shallow voids under the turfmesh and the underlying rockfall netting is visible. It is clear that water collects in these voids and the subsequent mud gets squeezed up through the mesh when walked on. On a dry day (5th April 2016), the surface was not slippery and the turfmesh covering the voids was intact and hence not a trip hazard.

In the very wet winter of 2014/15 the original path became muddy where there was no vegetation, but the trial area became both muddy and slippery– albeit shallow mud on a basically level surface. The vegetation on the main path quickly recovered after the winter whereas the trial area remained without any substantial grass cover.

The conclusion from these observations is that the surfacing methodology used in this trial is not a suitable surface for such a well-used path. It may be suitable for lightly used paths. The photos below illustrate the issue.

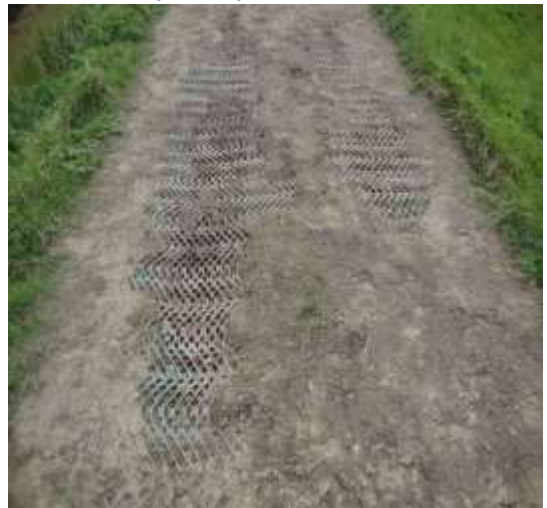
It is a concern that the turfmesh is sitting directly on, or suspended over the rockfall netting and thus may degrade or be physically damaged, resulting in difficult walking or trip hazards.

Close up of exposed turfmesh

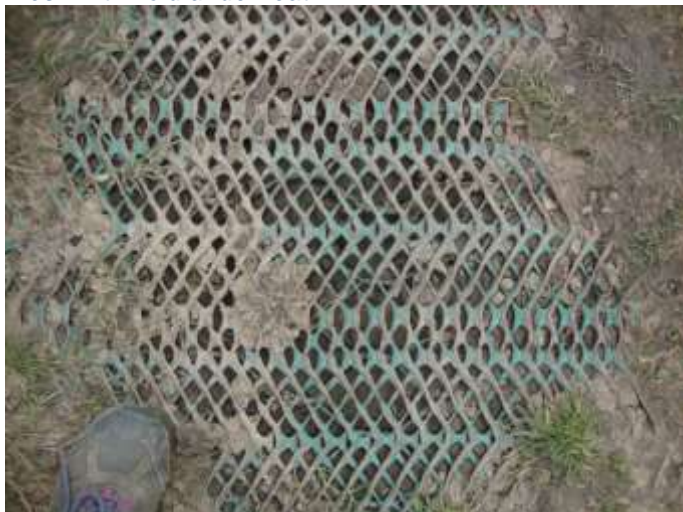
Mesh with void underneath
