Suffolk Estuary Flood Defence and Right of Way Trial on the Deben Estuary, (Flood Cell 12), north of Martlesham Creek

Update April 2016 – including interim recommendations

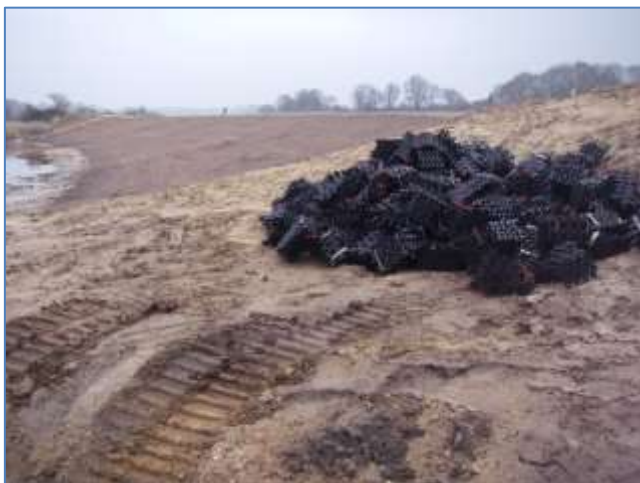
Cellular HDPE mats (Tenax) delivered on site

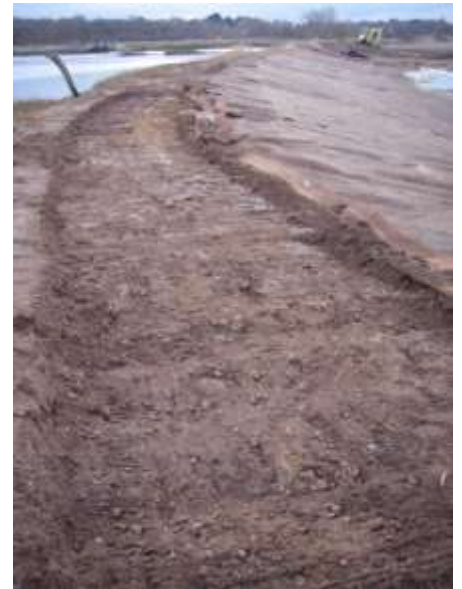
*Excavation for crushed concrete foundation.
This photo illustrates the curve of the path at this location (looking west)*

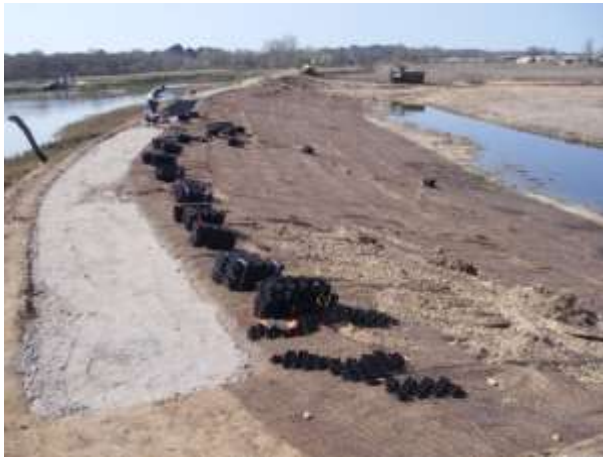
*Foundations prior to mat placement
(looking west)*

*Mats laid out on the base being infilled with crushed concrete. This illustrates that the mats have to be staggered to accommodate the curve of the path.
(looking east)*

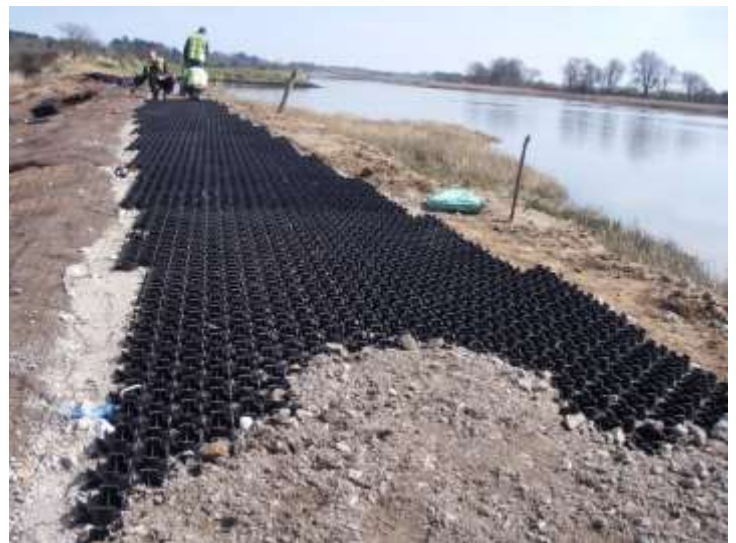
Partially complete of path surfacing across western spillway (looking east)

Note the use of the turf reinforcement mesh on the landward slope of the spillway

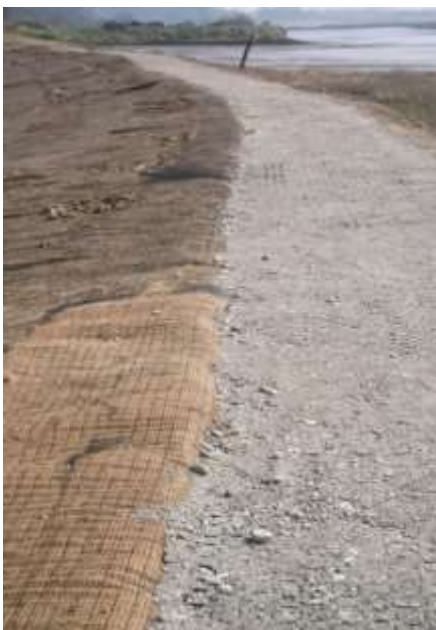
Finished path (looking east)

The only thing left to do is to seed the turf reinforced mesh. As well as a grass surface on the landward slope it is hoped that vegetation will re-establish itself along the path margins.

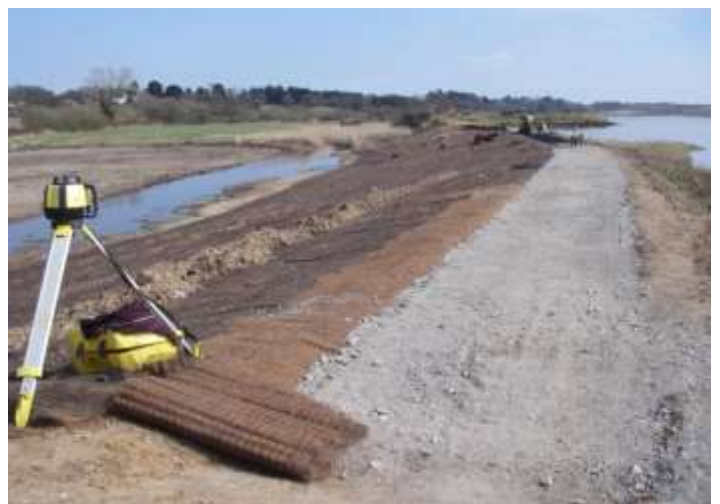
Close up of finished surfacing

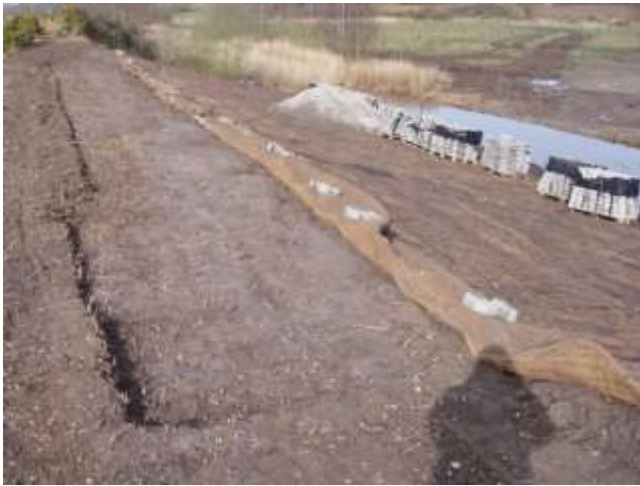
Site strip prior to mesh placement (looking west)

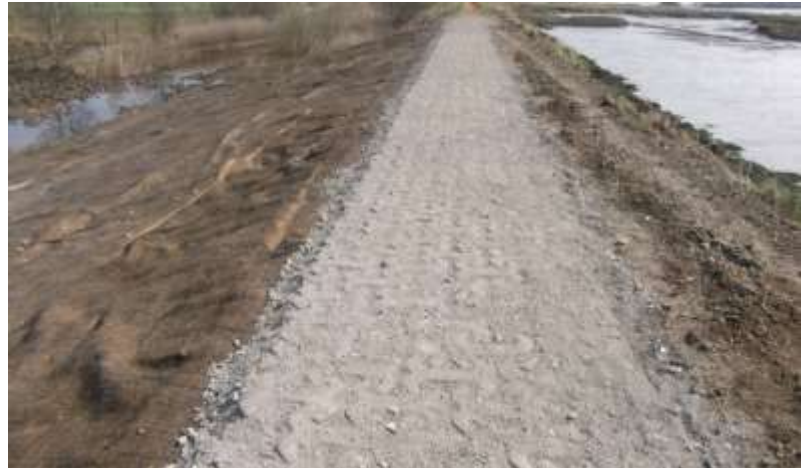
Completed path across spillway. (looking east).

Note the turf reinforcement mesh on the landward slope – awaiting seeding.

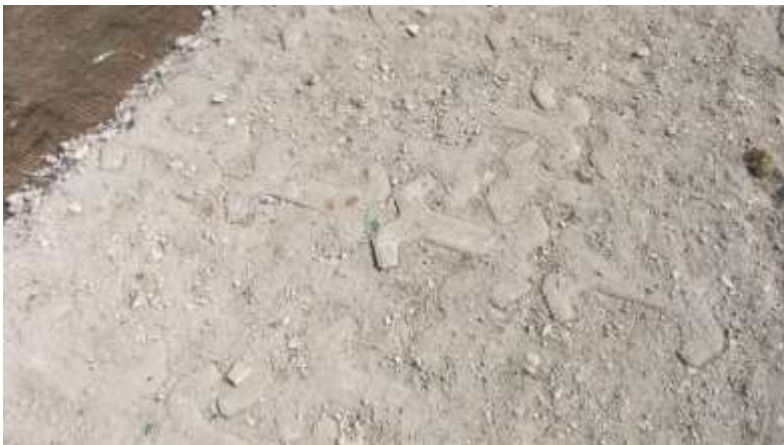
Close up of finished path surfacing

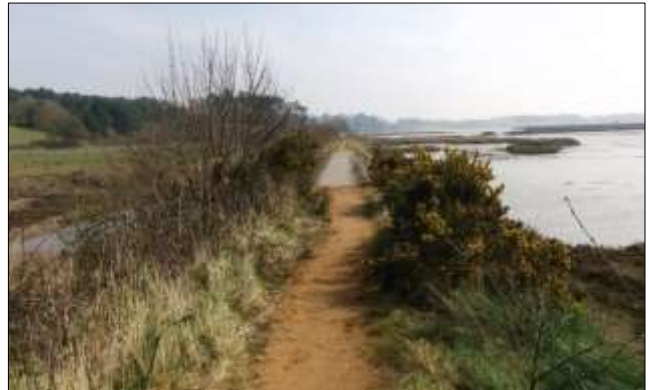
*Existing hoggin path
looking east towards spillway 2*

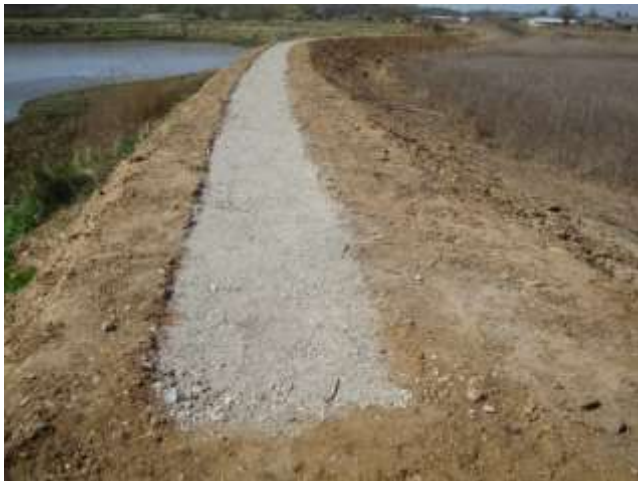
*Crushed concrete, prior to compaction,
on first section of the wall
(looking east)*

It is worth noting that due to the poor quality of the initial crushed concrete a further covering of finer crushed concrete was added about a month later both to the crushed concrete and Tenax infill surfaces.
